Quality Assurance in solar thermal heating and cooling technology

One year exposure tests performed throughout Europe on different solar thermal collectors

CSTB – Centre Scientifique et Technique du Bâtiment
B. Khebchache, SCTB, bouzid.khebchache@cstb.fr
C. Buscarlet, CSTB, carol.buscarlet@cstb.fr

Deliverable D2.2 – R2.11

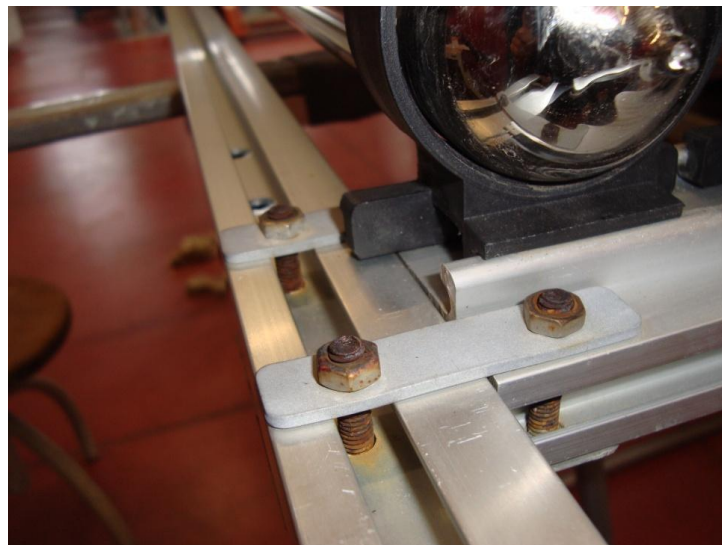
Classification 1: Corrosion was observed in the screws supporting the collector structure.

Figure 1 : corrosion in the screws supporting the collector frame

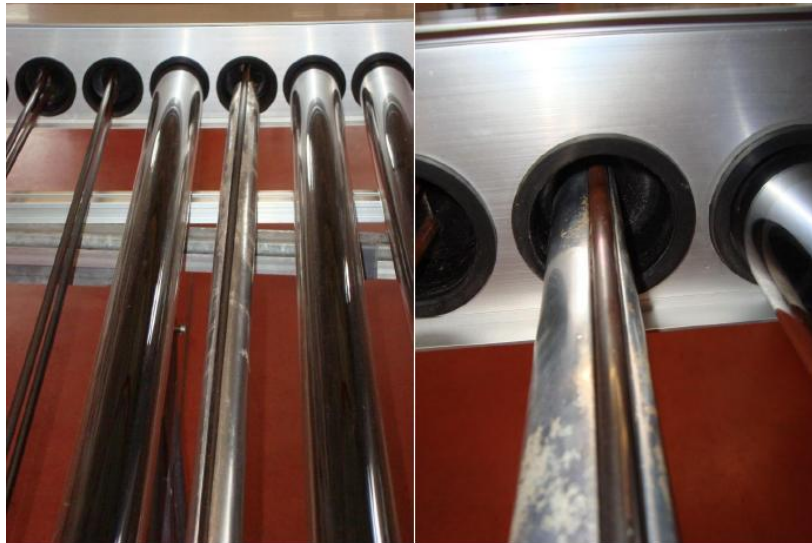
Classification 1: 4 fins with little damage affecting contact between the U tube and the absorber tube.

Figure 2,3: Fins deformed with some points having poor contact with the absorber

Conclusion: the laboratory concluded that these damages have no impact on the thermal performance of the collector.

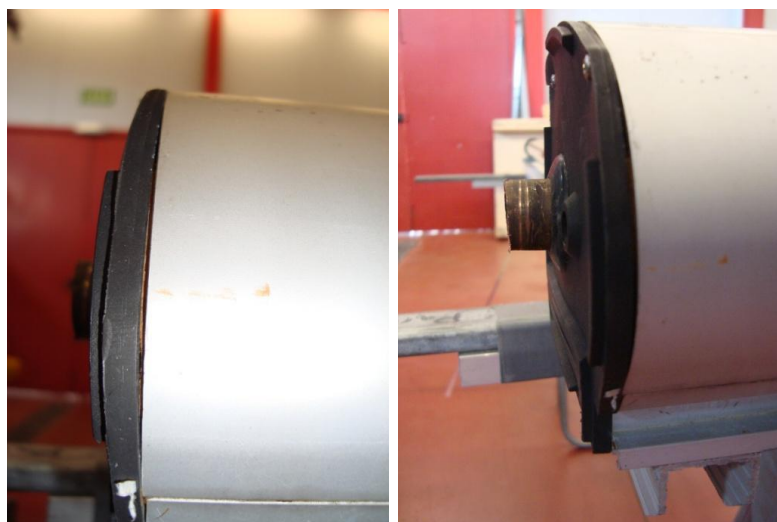
- a) Warping was observed in collector box, caused by expansion of the polyurethane.

Figure 4,5 : Problems with collector box after the long term exposure test

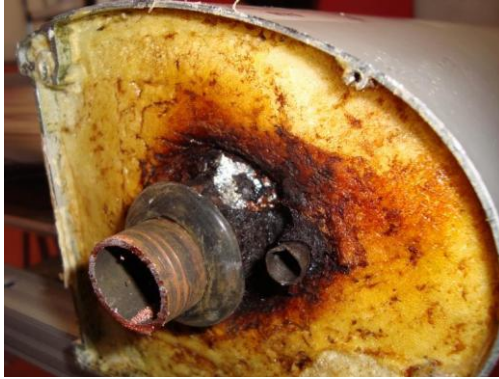
- b) Colour changing and some degradation was observed in the insulation.

Figure 6 : Color changing and some degradation in the collector insulation

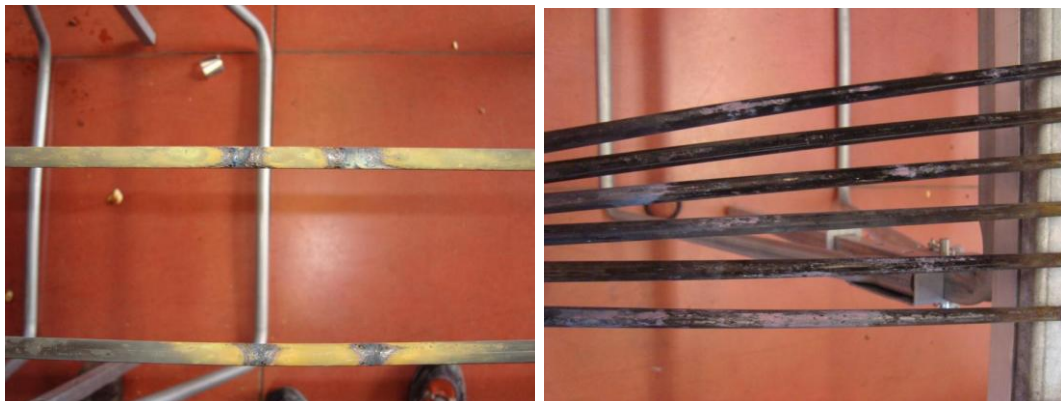
- c) From all the tubes inspected, 4 tubes contained little liquid remaining and tube n°5 contained no liquid at all, only some dirt.
- d) Corrosion was observed in all copper tubes, but more evident in the beginning/end of every fin.

Figure 7,8 : Corrosion observed in the copper heat pipes

Conclusion: the laboratory concluded that the damage c) has a « major » impact and the damage d) has a « moderate » impact on the performance of the collector.

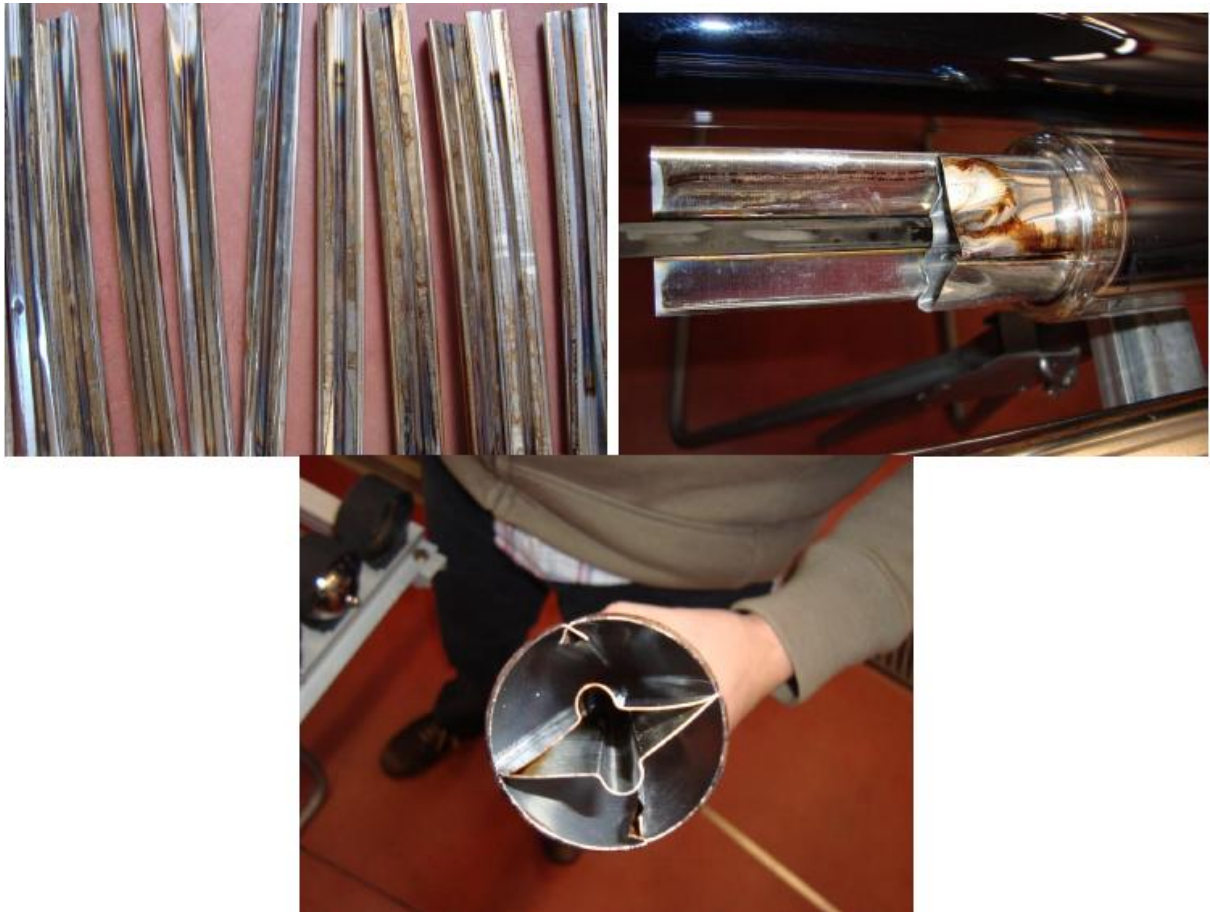
- e) Degradation in most of the fins (see figure 9). One fin showed deficient assembly on the beginning (see picture 10). In another fin, there was poor contact between the fin and copper tube (see figure 11).

Figure 9,10,11 : Problems observed with the collector fins

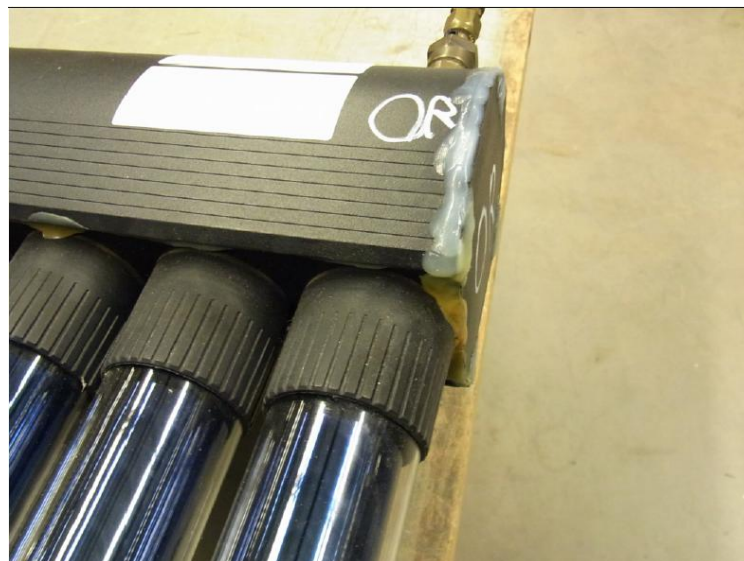
Classification 0 (but with remark): rain penetration

It was known that the side covers are not water tight. To prevent from influencing the test because of a known problem, the side caps were sealed by SPF before starting the one year test.

Figure 12: view of side cap sealed

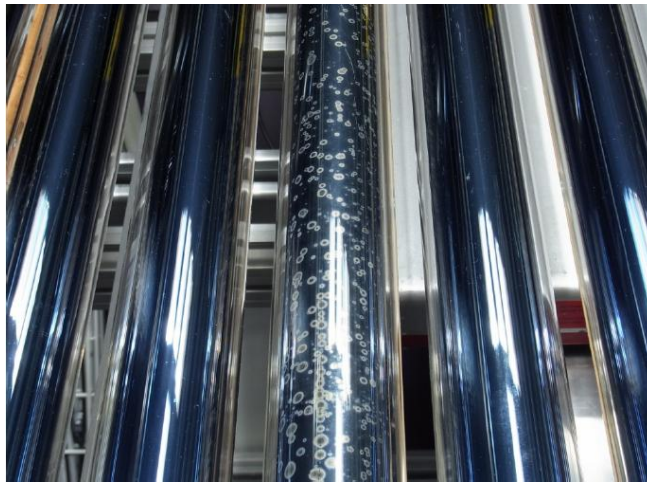
Classification 2: blistering

Conclusion: the laboratory concluded that the damage has a « major » impact on the collector performances.

Figure 13: view of the damaged tube #4

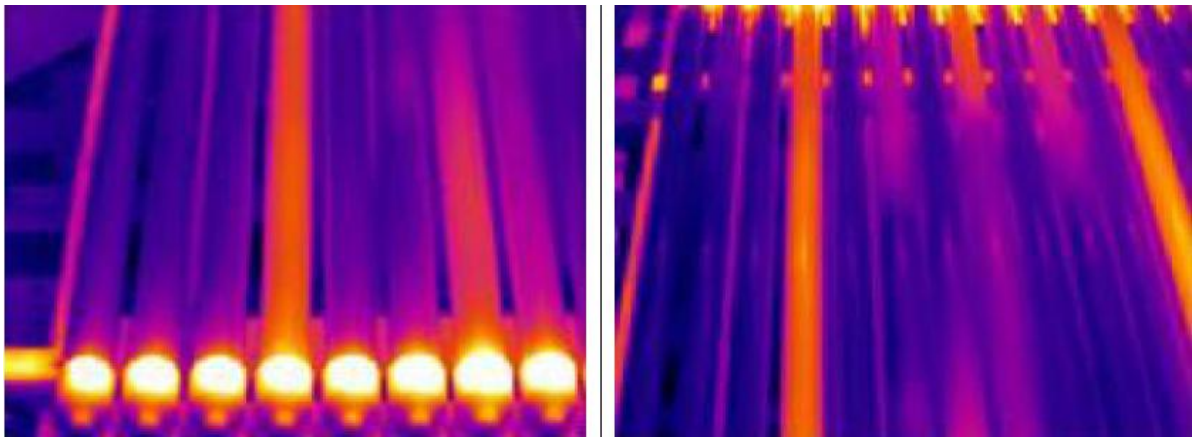
Classification 2: Vacuum losses and colour changing

On tube #4 the vacuum loss is obvious (getter / absorber coating). Tube #12 looks ok, but the IR photo reveals a vacuum problem (see infrared pictures).

<p>Vacuum loss on tube #4 Hotter tube (vacuum ?) on #7</p>	<p>Vacuum loss on tube #4 and #12 Hotter tube (vacuum ?) on #6 #8 #10</p>
--	---

Figure 14,15: infrared pictures

Conclusion: the laboratory concluded that both damages have « major » impacts on the collector performances.

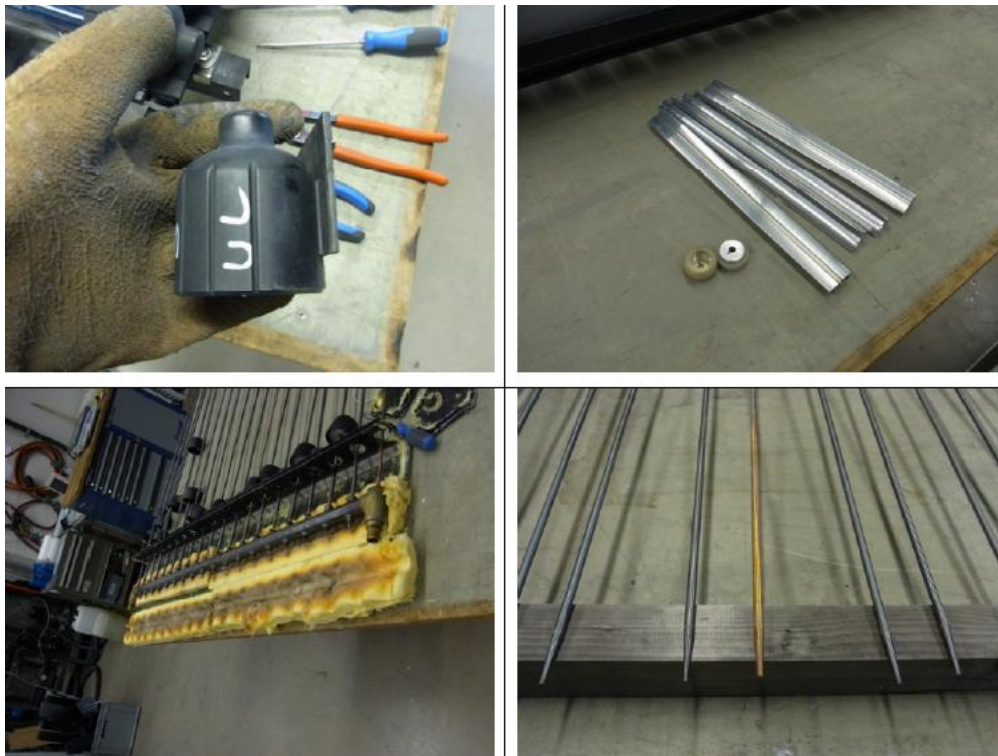
Figure 16-19: global view of components

All the components parts look surprisingly ok. No signs of severe degradation are visible. Interesting to see that all heat pipes and all the copper pipe work has been blackened. Exception: heat pipe of tube #8.

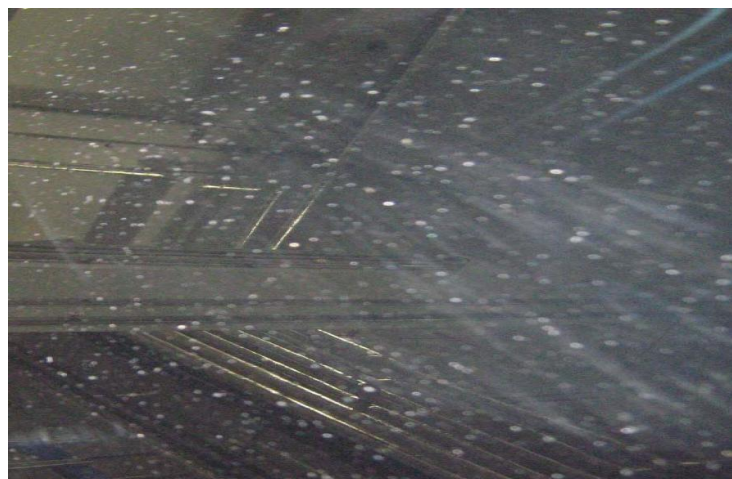
Figure 20: view of the dusting on the absorber sheet

Some areas of the absorber have been dusted with the particles of the insulation.

Conclusion: the laboratory concluded that the damage has a « moderate » impact on the collector performances.

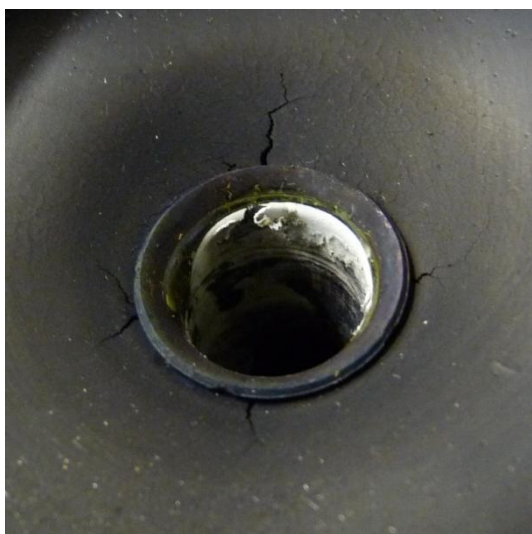
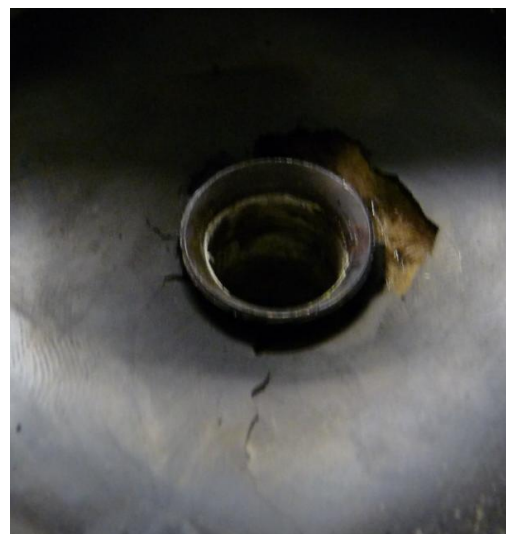
Classification 2 : cracking

Five gaskets on 10, between heat pipes and collector box are stiffened and broken.

Conclusion: the laboratory concluded that the damage has a « major » impact on the collector performances.

Figure 22, 23: broken gaskets view

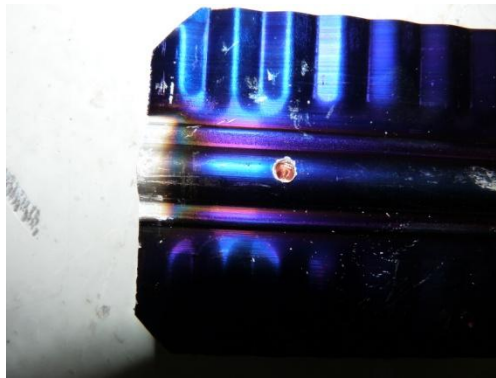
Classification 1: one little detachment on surface

Conclusion: the laboratory concluded that the damage has a « minor » impact on the collector performances.

Figure 24: absorber coating damage

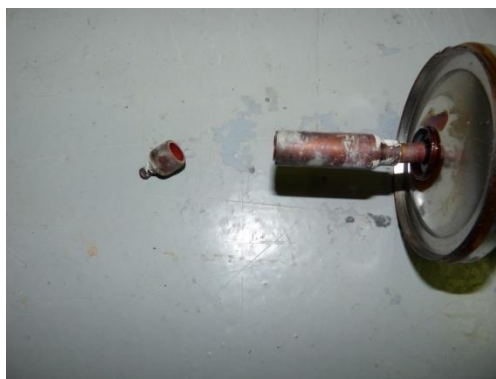
Classification 2: the 10 heat pipes still contained fluid after opening. However, three of them contain a tiny quantity.

Figure 25: view of heat pipe opened

Conclusion: the laboratory concluded that the damage has a « major » impact on the collector performances.

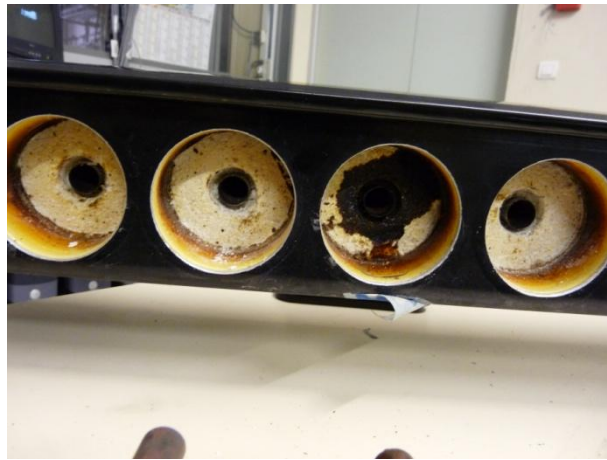
Classification 2: breakage of 5 frame gaskets of 20.

Figure 26: view of cracked gasket

Conclusion: the laboratory concluded that the damage has a « major » impact on the collector performances.

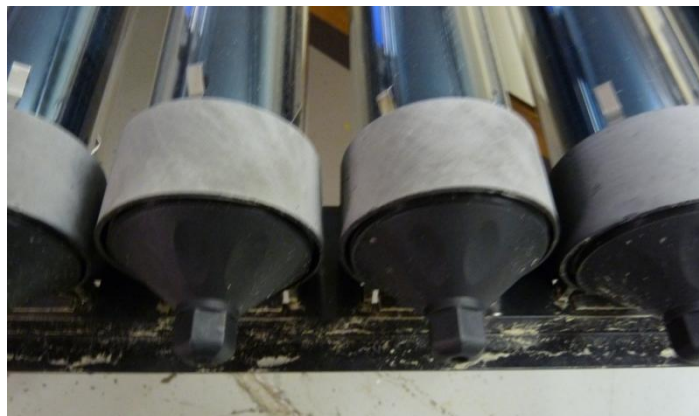
Classification 1: discoloration of vacuum tubes gaskets

Figure 27: discoloration of vacuum tubes gaskets

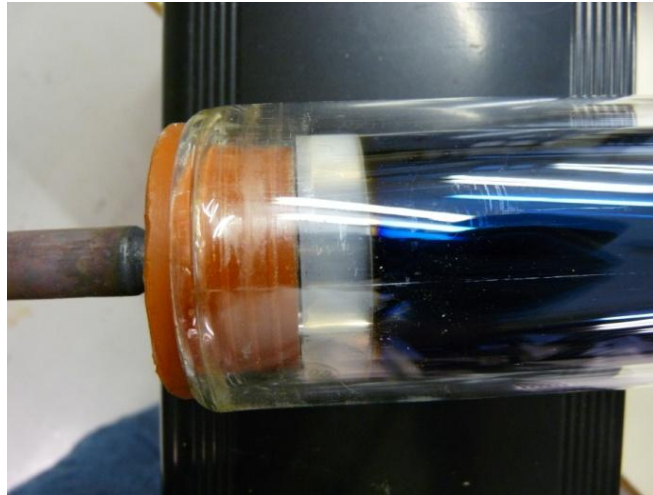
Classification 2: white deposit on the inner glass tube

Figure 28: whitish deposit on the tube

Conclusion: the laboratory concluded that the damage has a « major » impact on the collector performances.

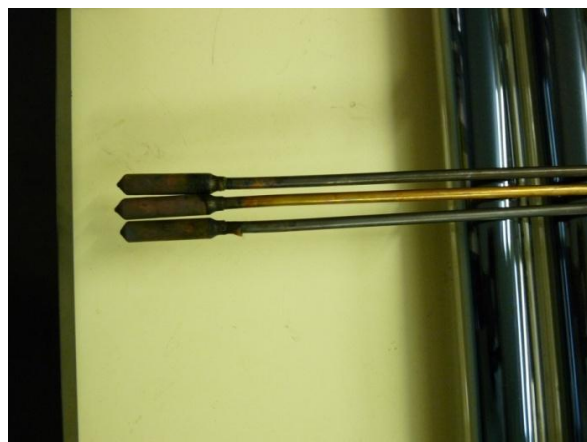
Classification 1: one of the 20 tubes hasn't blackened. The 20 tubes have liquid inside but with 3 different colours:

- 9 tubes have yellowish liquid
- 6 tubes have blackish liquid
- 5 tubes have translucent liquid

Figure 29: heat pipes view

Conclusion: the laboratory concluded that the observation has a « minor » impact on the collector performances.

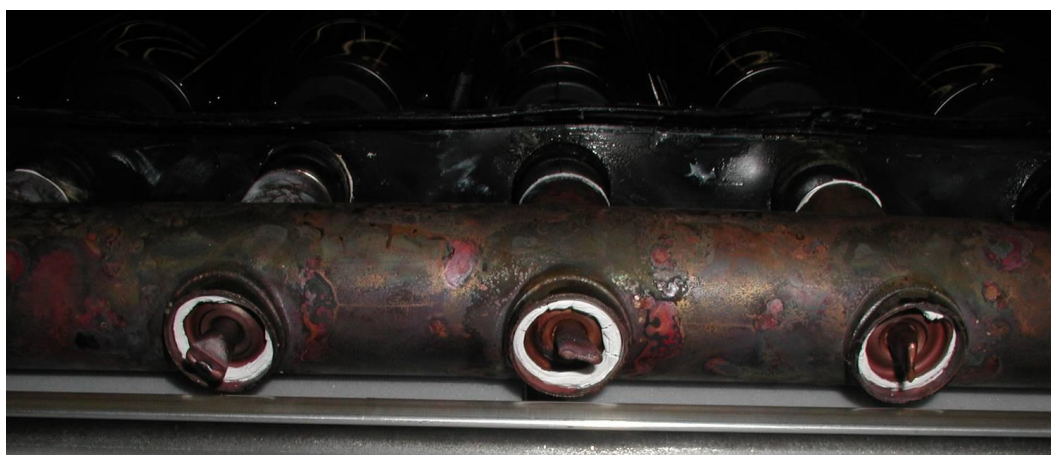
No degradation was seen except the heat transfer paste on top of condenser dried out. This degradation is confirmed by the results of two additional tests performed after the final test:

Picture 30) Dried out heat transfer paste on top of condenser (after one year exposure before renewing paste)

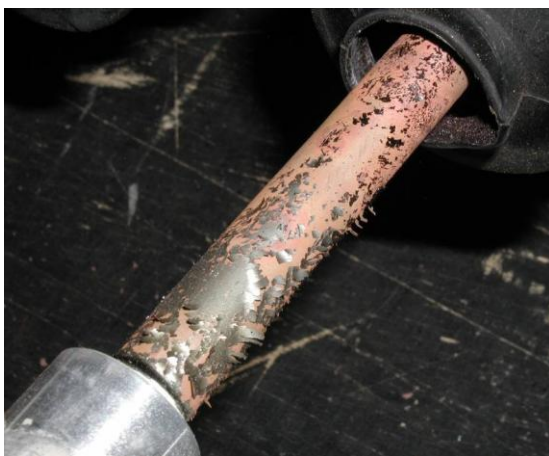
Classification 1: Traces of corrosion on condenser heatpipe outside evacuation

Picture 31) Traces of corrosion on condenser heatpipe outside evacuation

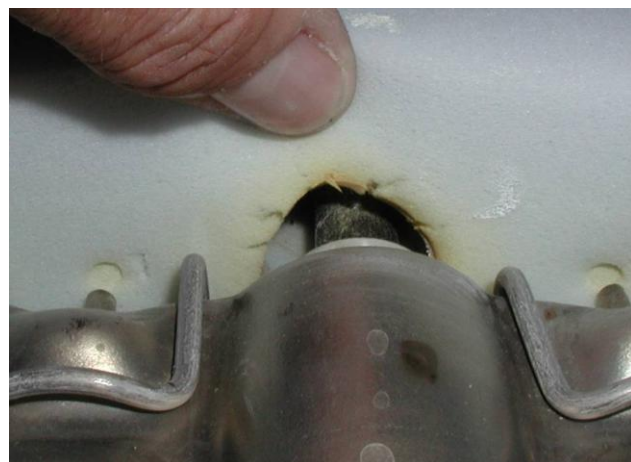
Classification 1: colour changing

Picture 32) Insulation at the heatpipe in manifold casing

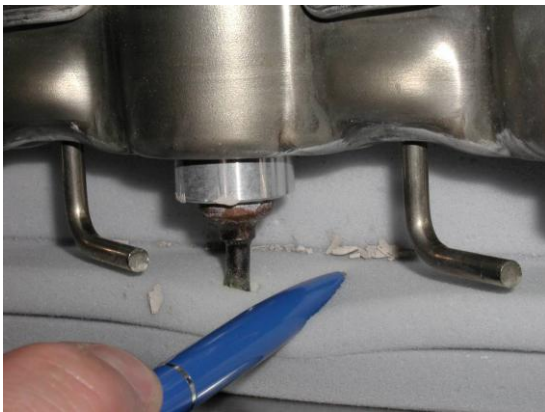
- In addition the heat transfer paste appears dried (see pictures 33 and 34)

Picture 33) Fragments of heat transfer paste in manifold casing (after 30 days exposure)

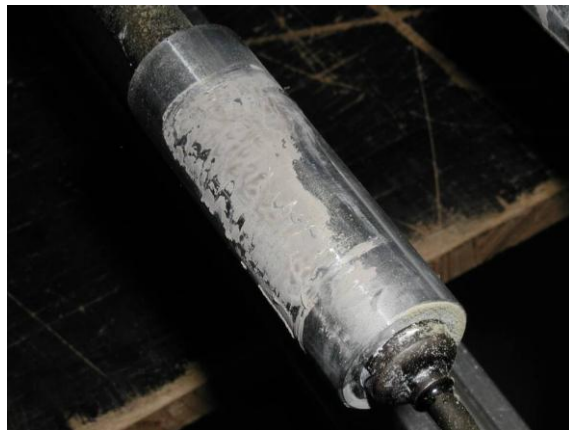
Picture 34) Dried out heat transfer paste on aluminium tube at condenser (after one year exposure before renewing paste)

The degradation of the heat transfer paste is confirmed by the results of an additional test performed after the final test:

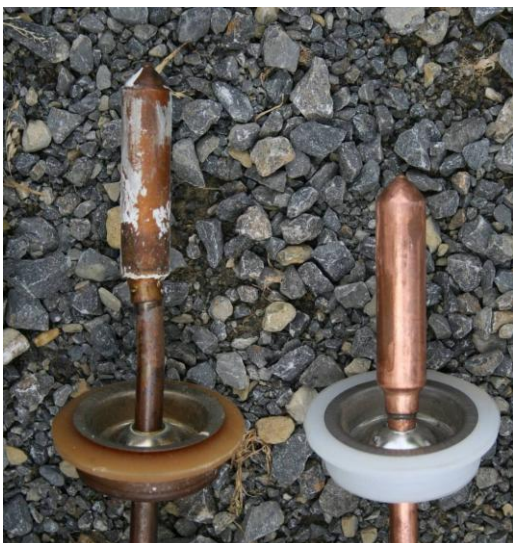
- Gaskets: Classification 1 – loss of elasticity

Picture 35) gaskets at upper dewar tube end

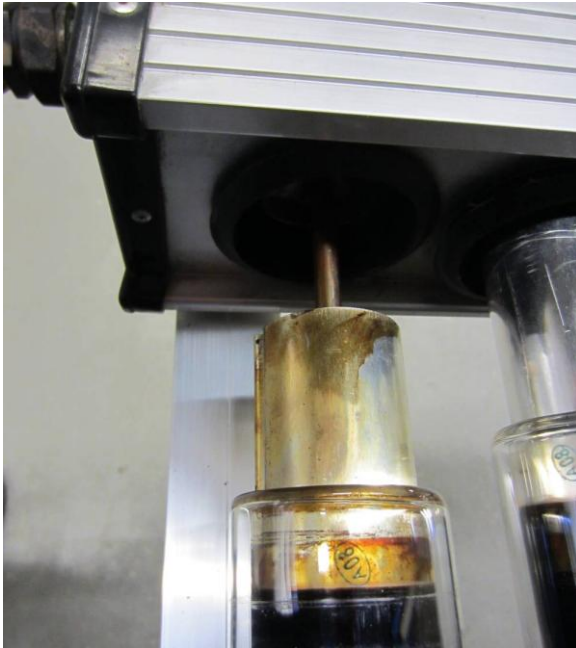
- Heat pipes: Classification 1 - Traces of corrosion on condenser

Picture 36) heat conductors and glass tube after exposure

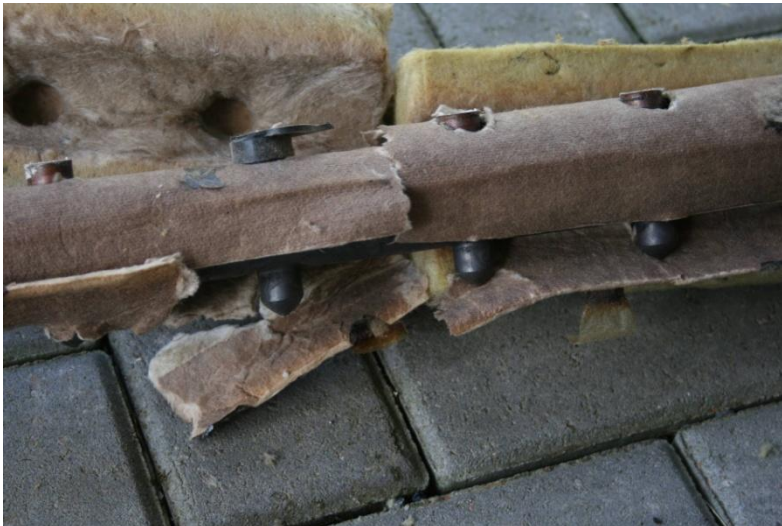
- Insulation : Classification 1 – Colour changing

Picture 37) clam-shell insulation of manifold at final inspection
