Test Report

Freeze resistance tests of Heat Pipes for Solar Collectors following

DIN EN 12975-2: 2006

TÜV Report No.: 21220036_HPQual

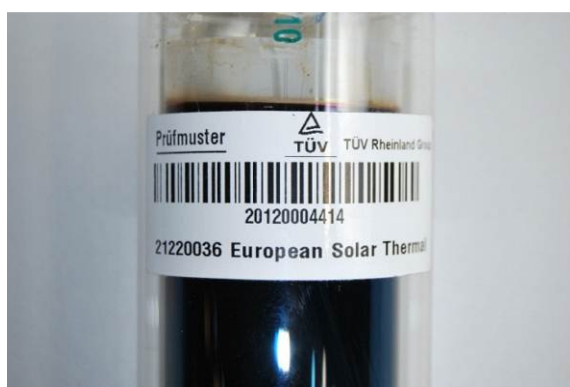
Fig. 01: Type 1: Test samples from TÜV

4.5.1 Type 1 (TÜV)

No widening was detected. All deficiencies are within the overall measurement uncertainty.

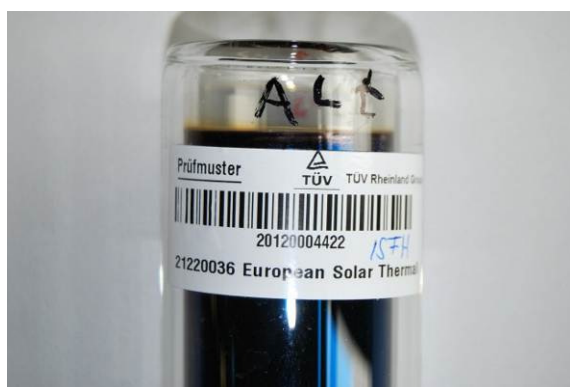
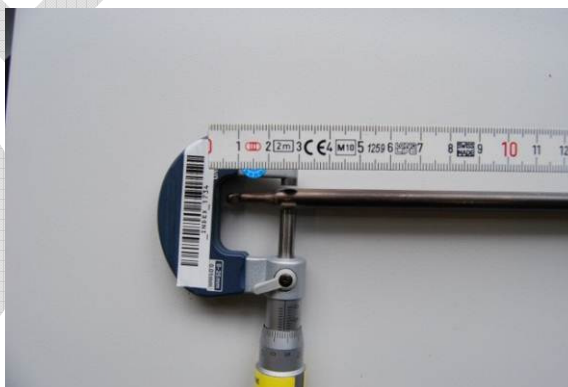
Fig. 02: Type 2: Test samples from ISFH

4.5.2 Type 2 (ISFH)

No widening was detected. All deficiencies are within the overall measurement uncertainty.

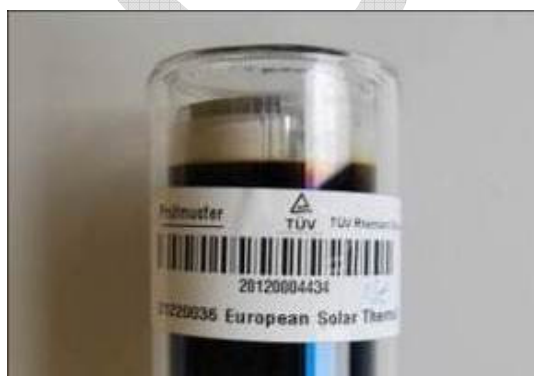
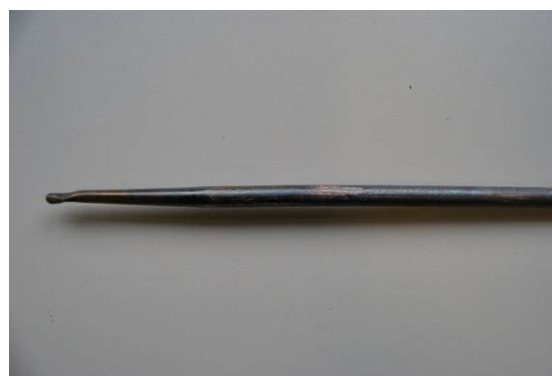
Fig. 03: Type 3: Test samples from ISE

4.5.3 Type 3 (ISE)

No widening was detected. All deficiencies are within the overall measurement uncertainty.

Because of conic shape of head pipe bottom, the measurement of diameter is more difficult. The high precision micrometer calliper is not possible to use, only a regular calliper.

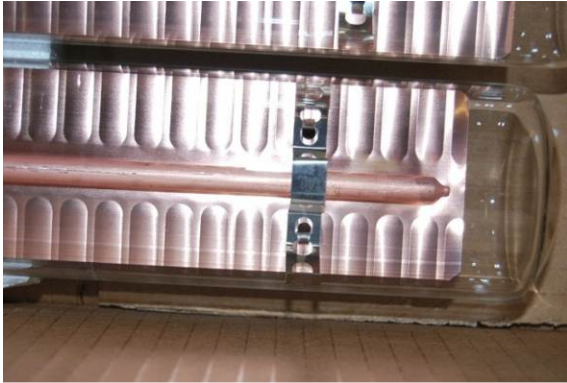
Fig. 04: Type 4: TÜV II, Single glass evacuated tube

4.5.4 Type 4 (TÜV II, single glass tube)

No widening was detected. All deficiencies are within the overall measurement uncertainty

Because of the construction “single glass tube” a comparison after 0 and 20 cycles was not possible. The heat pipe didn’t show any problems. Even the additional single heat pipes with destroyed glass tube didn’t show any problems.

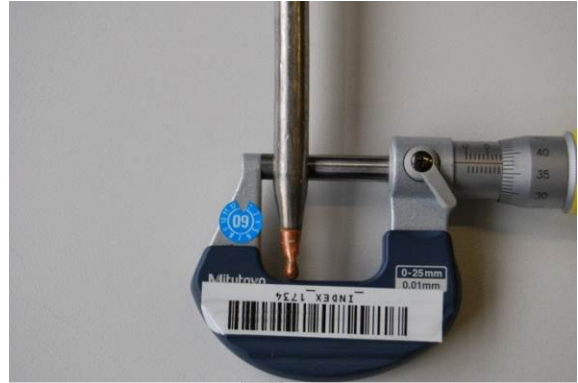
Fig. 05: Type 5 and 6: TÜV III, Additional heat pipe tested as single one and assembled into all glass tube

4.5.5 Type 5 (TÜV III, assembled)

Widening was detected. It need to be discussed, if this value is a failure after 20 cycles.

4.5.6 Type 6 (TÜV III, single heat pipe)

Massive widening was detected. Definitely a failed test, but with a more critical test setup.

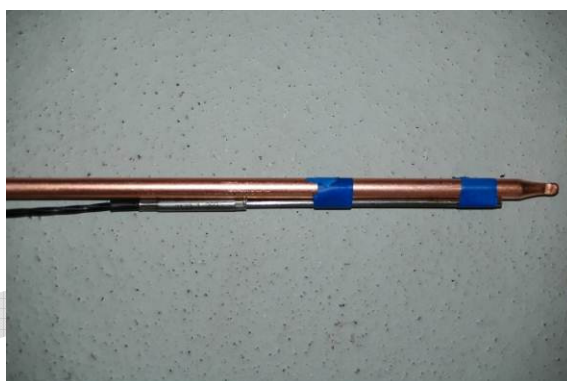
Fig. 08: Reference temperature sensor

The heat pipe with the reference temperature sensor will only be used to detect the temperature and won't be evaluated within final inspection.

The temperature sensor will be fixed on the lower end of the heat pipe close to the expected maximum level of fluid. The permanent temperature detection during test detected perfectly the point of freezing within the heat pipes (enthalpy for phase changing at or close to 0°C)

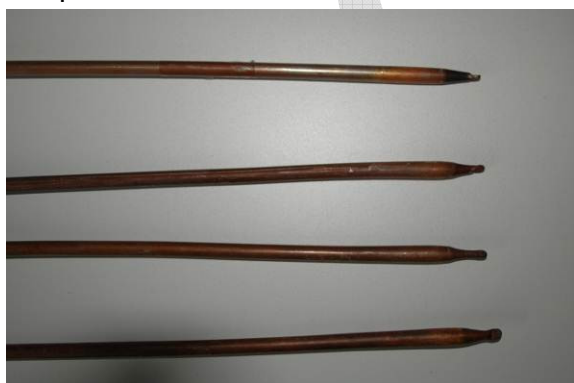
Fig. 09: After 3 EN Cycles (10 h each)

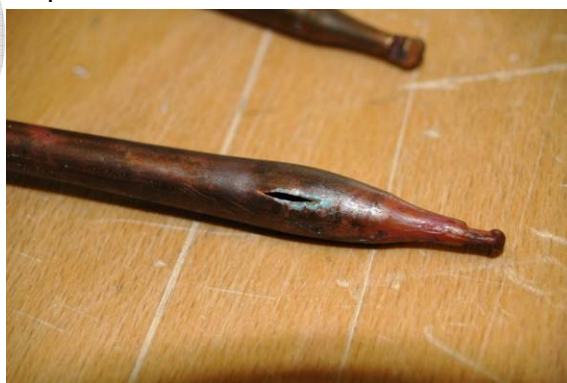
To get a sufficient test result, three temperature cycles are not enough. Solar thermal collectors should have a lifetime of more than 20 years, so one freeze cycle per year is an appropriate test criteria.

Fig. 10: After 20 EN Cycles (10h each)

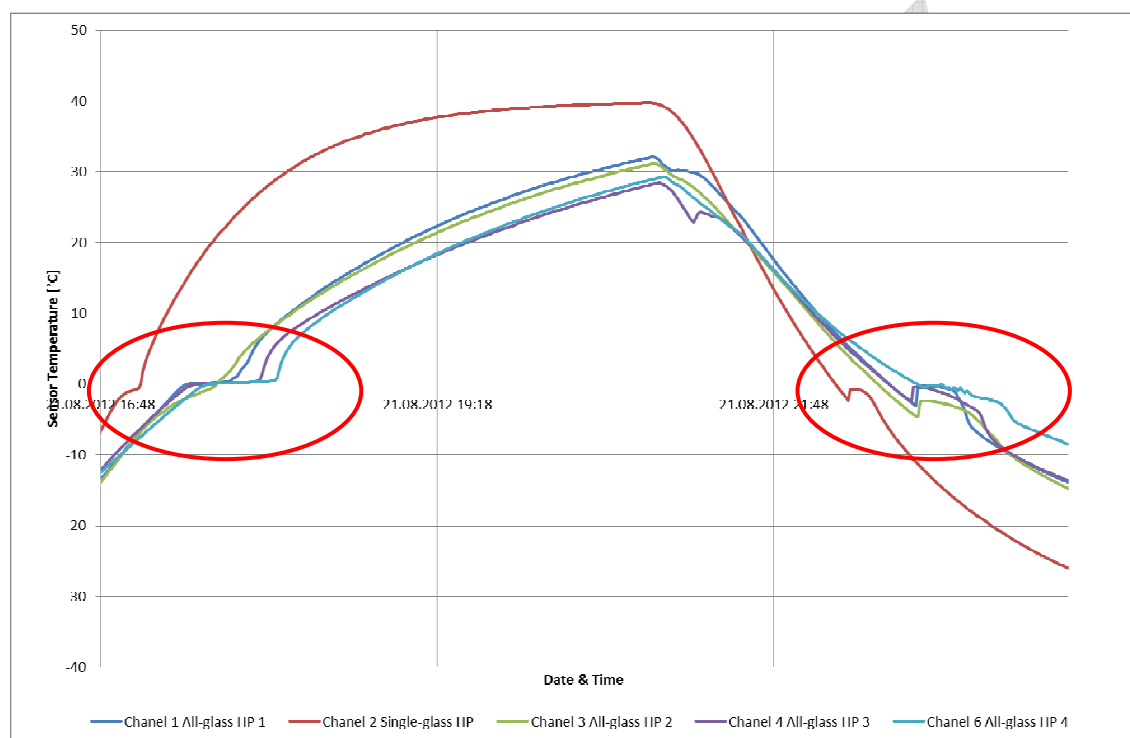
Fig. 11: phase change within heat pipe

Even there might be not the full quantity of fluid inside the heat pipe any more, there's also a clear point of freezing measurable (see red line within graph above). As this kind of tubes showed always a much lower thermal capacity and time constant as conventional all glass tubes including heat pipes, this special temperature measurement may not be necessary.

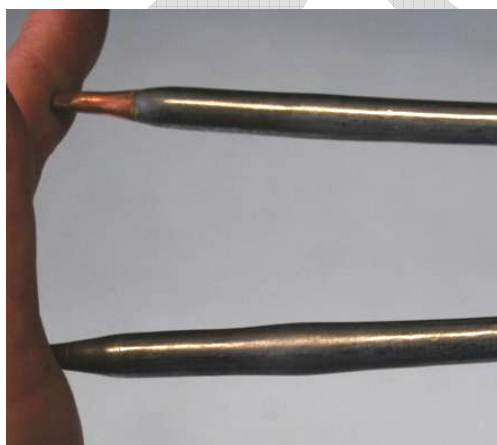
Fig. 15: Comparison of assembled and single heat pipe after 20 test cycles.

This additional test sample in combination with the different test set ups is a perfect indicator for a reasonable pass/ fail criteria. From our point of view. Type 5 had failed, so the maximum allowed widening value under consideration of measurement uncertainties shall not be more than 2 mm.
