Quality Assurance in solar thermal heating and cooling technology

One year exposure tests performed throughout Europe on different solar thermal collectors

CSTB – Centre Scientifique et Technique du Bâtiment
B. Khebchache, SCTB, bouzid.khebchache@cstb.fr
C. Buscarlet, CSTB, carol.buscarlet@cstb.fr

Deliverable D2.2 – R2.11

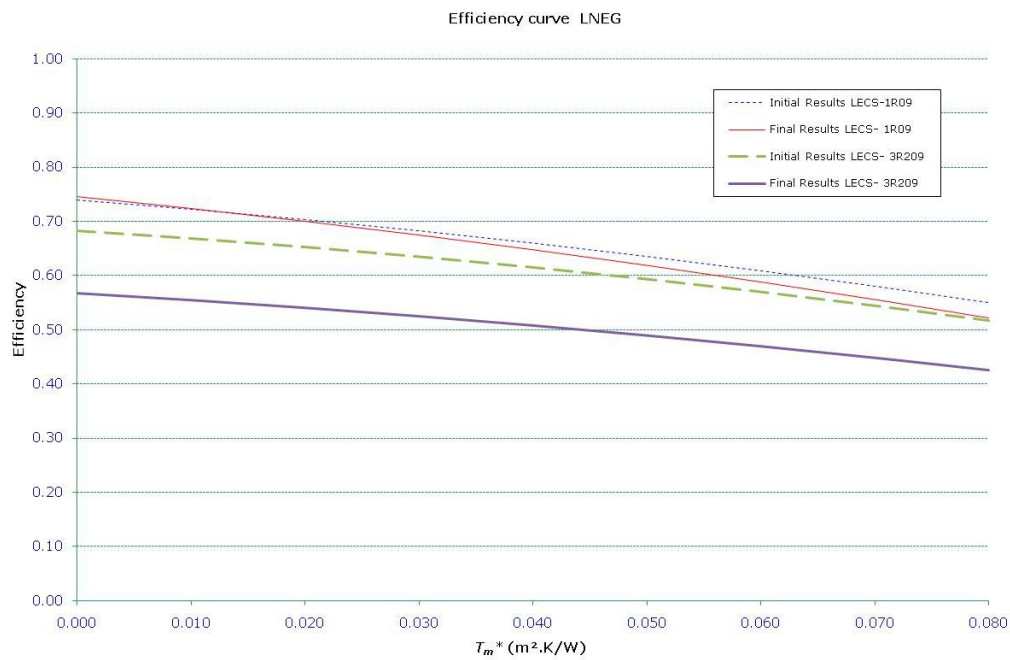
Classification 1: Corrosion was observed in the screws supporting the collector structure.

Classification 1: 4 fins with little damage affecting contact between the U tube and the absorber tube.

Conclusion: the laboratory concluded that these damages have no impact on the thermal performance of the collector.

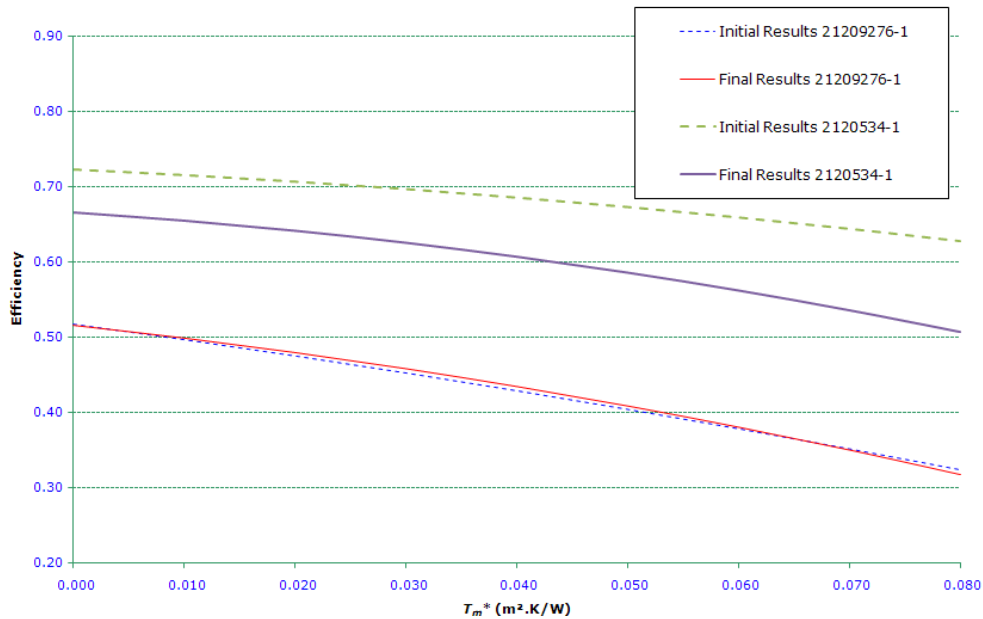
No damages observed (no final inspection because no degradation).

Classification 2 : cracking and rain penetration

Conclusion: the laboratory concluded that both damages have a « major » impact on the collector performances.

Classification 1 : water retention and degradation

Conclusion: the laboratory concluded that both damages have « moderate » and « minor » impacts respectively on the collector performances.

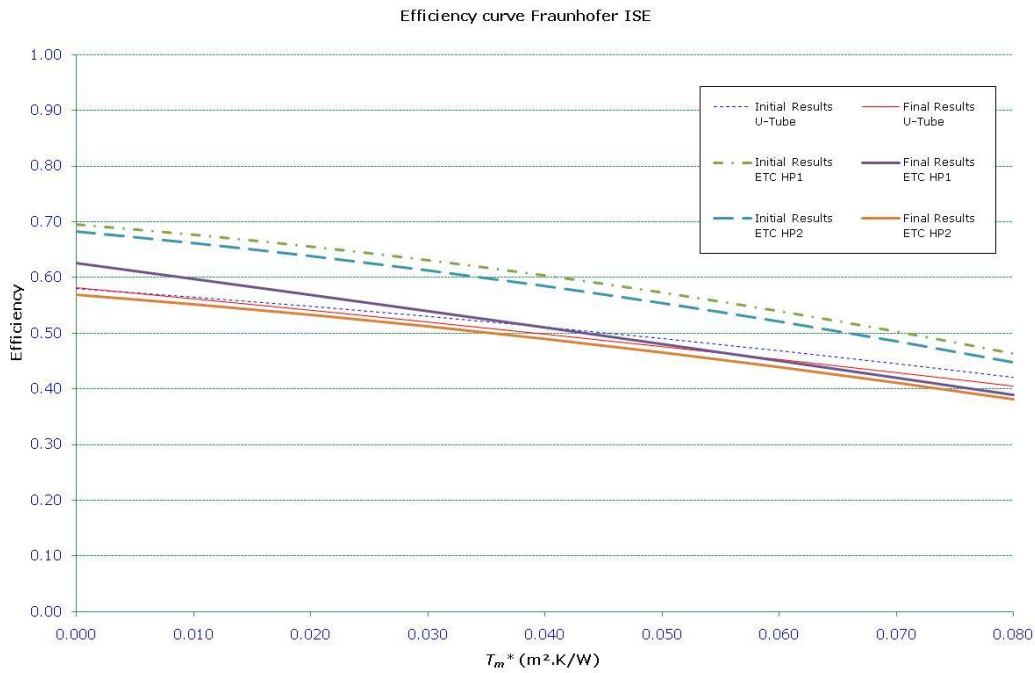
No observation done, the exposure period has been pursued.

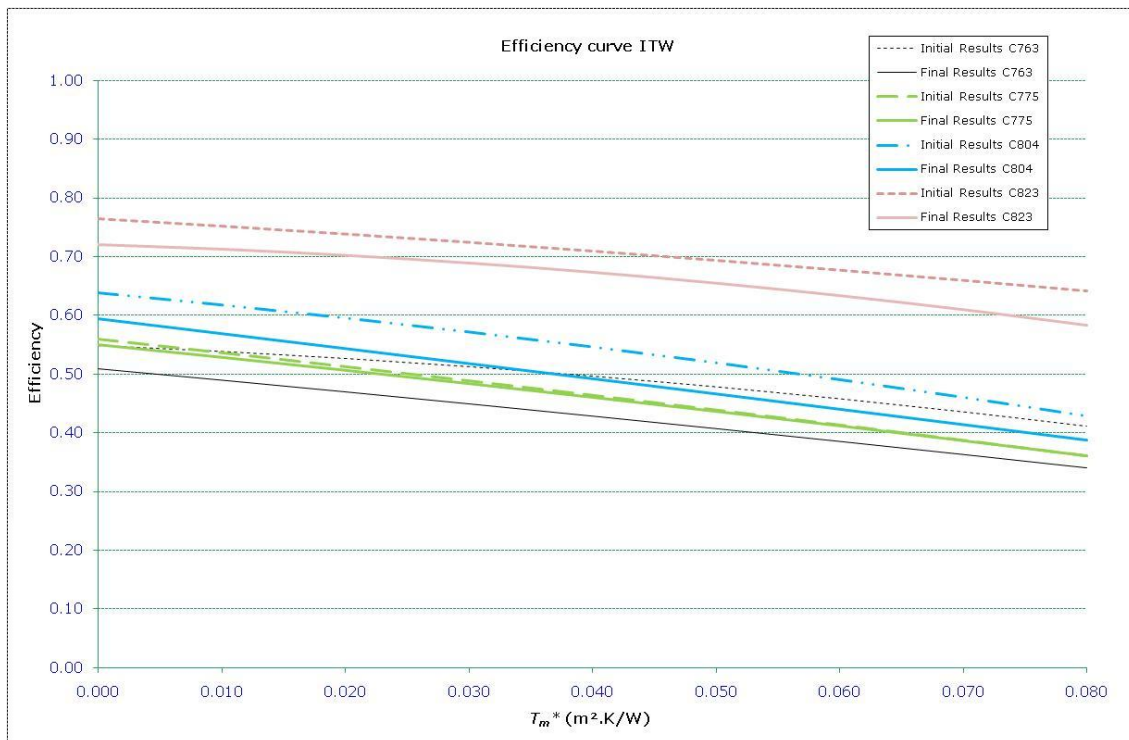
Only the collector C823 has been opened for observation, the laboratory wanted to extend the exposure period of the others.

Classification 1 : corrosion

Conclusion: the laboratory concluded that the damage has no impact on performances and the impact was considered like « minor ».

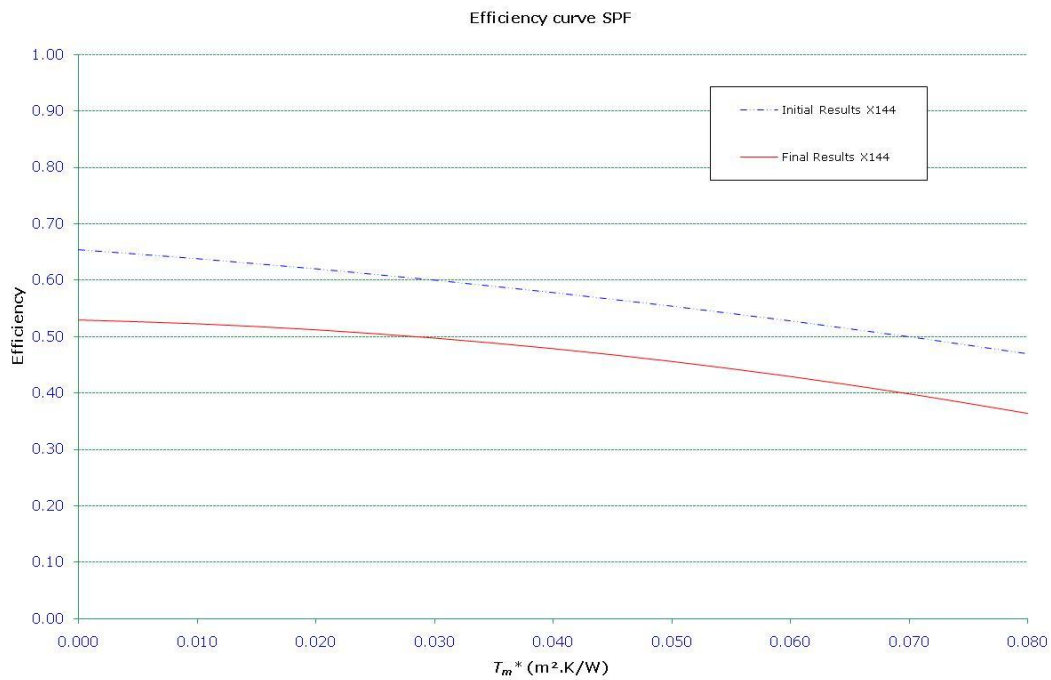
Conclusion: the laboratory concluded that the damage has a « major » impact on the collector performances.

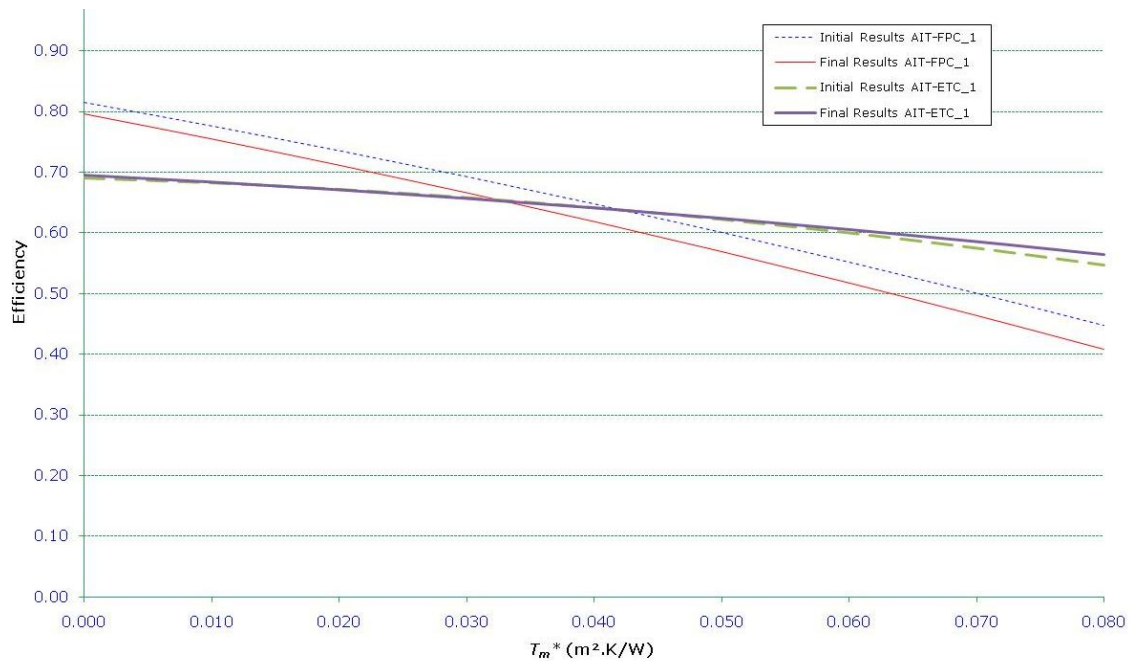
Some optical visible residues of water tears on the inner side of the cover caused by condensation.

Conclusion: the laboratory concluded that the damage has a « moderate » impact on the collector performances.

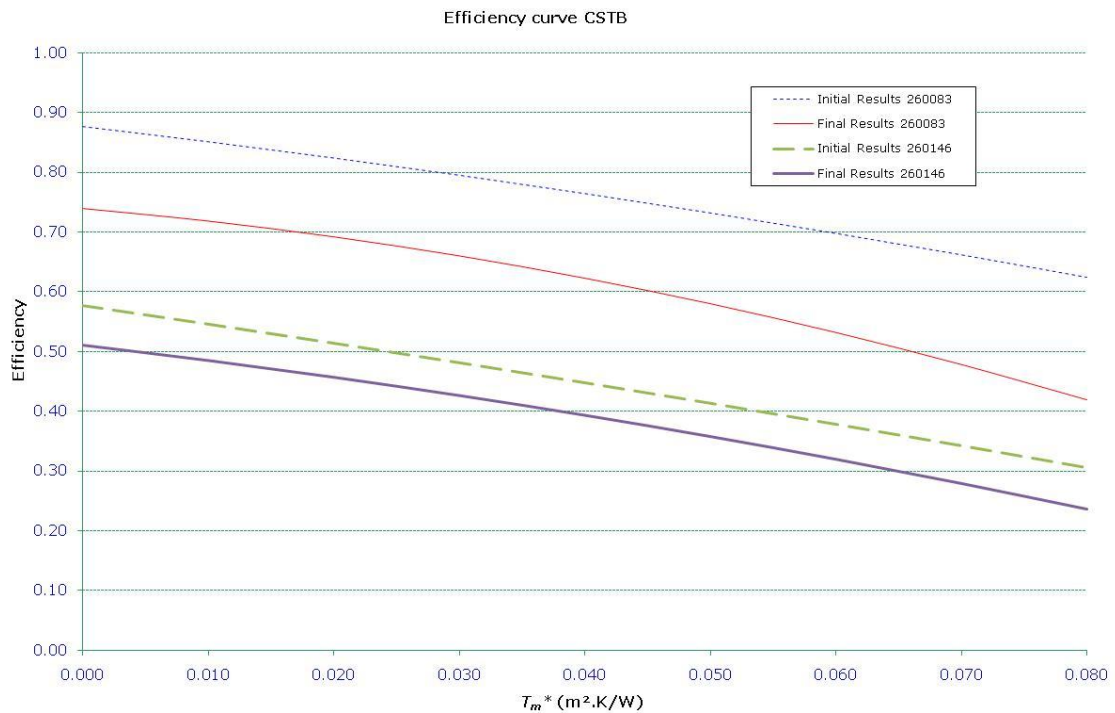
Classification 2 : cracking

Five gaskets on 10, between heat pipes and collector box are stiffened and broken.

Conclusion: the laboratory concluded that the damage has a « major » impact on the collector performances.

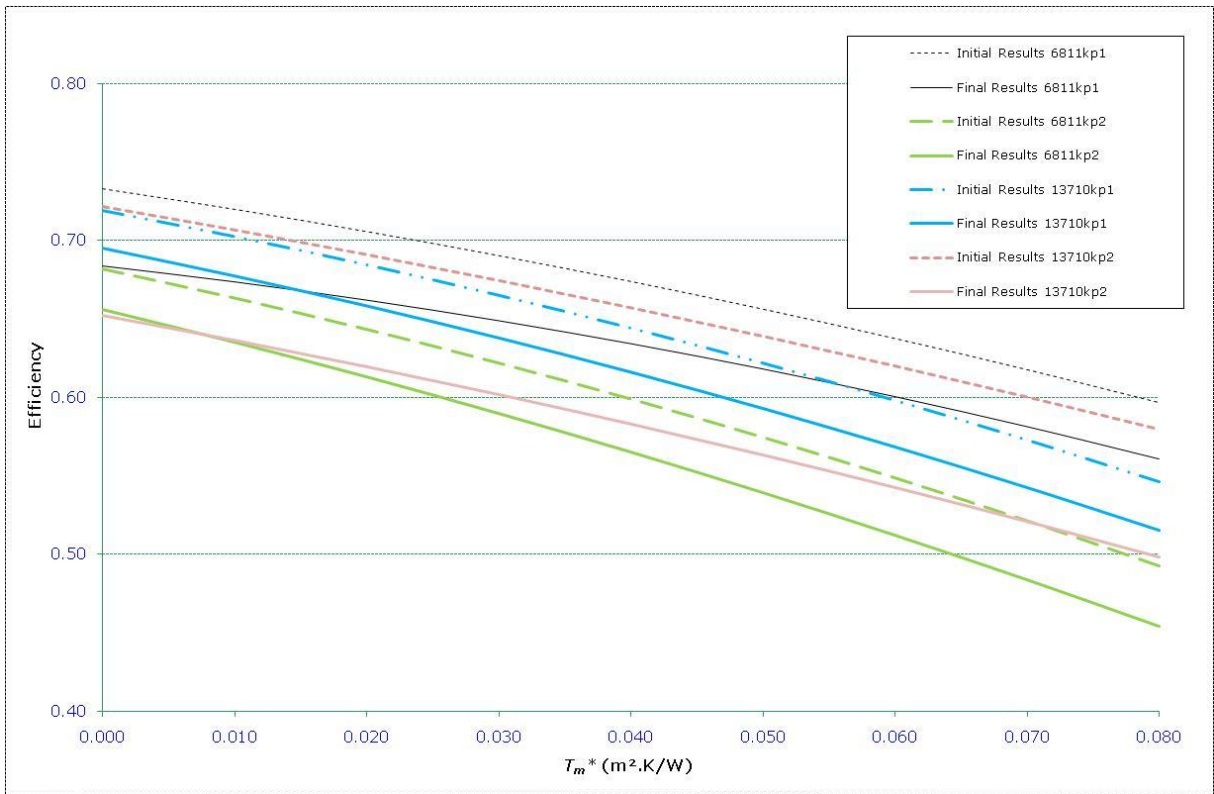
No degradation was seen except the heat transfer paste on top of condenser dried out. This degradation is confirmed by the results of two additional tests performed after the final test:

No degradation was seen but may be the heat transfer paste between condenser and manifold has deteriorated if one looks at the results of an additional test performed after the final test:

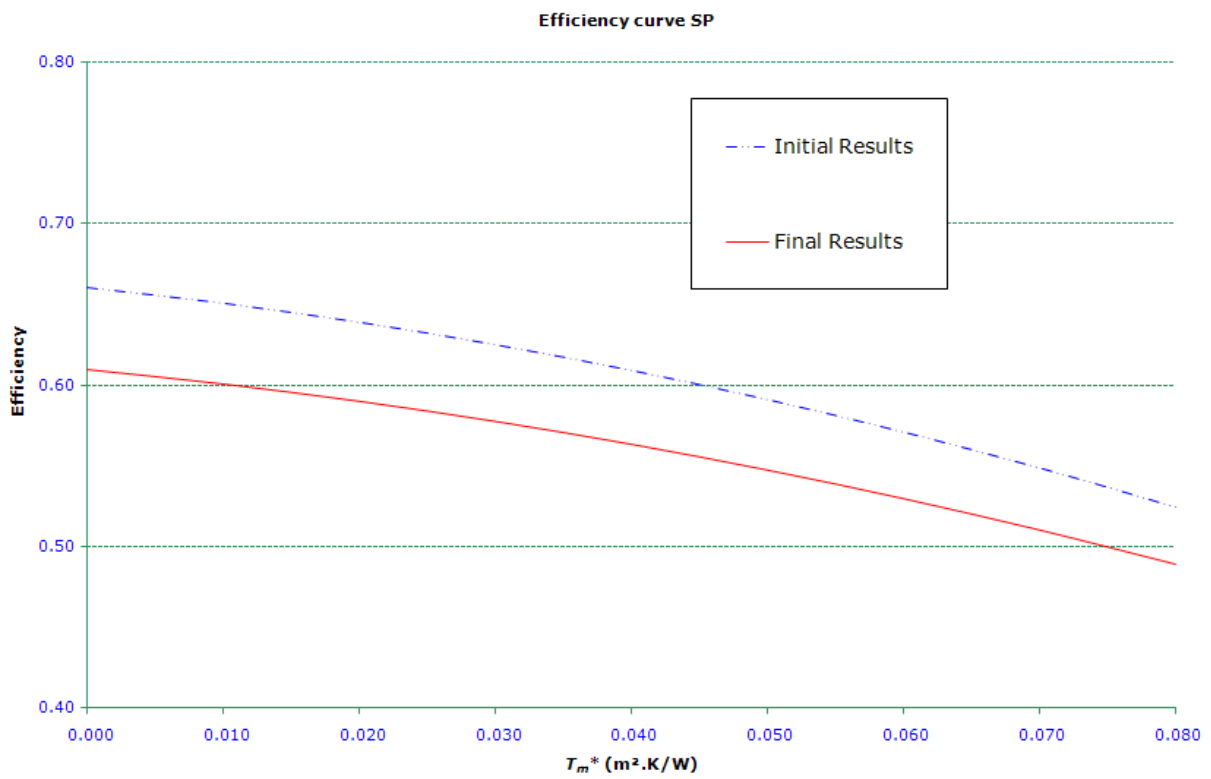
- Collector box / fasteners: Classification 0 no problem
- Mountings/structure: Classification 0 no problem
- Seals/gaskets: Classification 0 no problem
- Cover/reflector: Classification 0 no problem
- Absorber coating: Classification 0 no problem
- Absorber tubes and headers: Classification 0 no problem
- Absorber mountings: Classification 0 no problem
- Vacuum tube: Classification 0 no problem
- Heat pipes: : Classification 0 no problem (but liquid losses were not inspected)
- The heat transfer paste was dried out when opening the collector. This has probably affected the thermal performance, but it is not possible to determine at what extent. Therefore it would be out of interest to perform further measurements on several collectors with old and aged heat transfer paste to determine its affect on the thermal performance.
